[Docket No. 2003-SW-20-AD; Amendment 39-13181; AD 2003-08-53]

Airworthiness Directives; Eurocopter France Model SA-365N1, AS365-N2, AS 365 N3, and SA-366G1 Helicopters

2003-08-53 Eurocopter France: Amendment 39-13181. Docket No. 2003-SW-20-AD. Supersedes AD 2000-10-08, Amendment 39-11732, and 2000-10-08R1, Amendment 39-12452, both Docket No. 99-SW-34-AD.

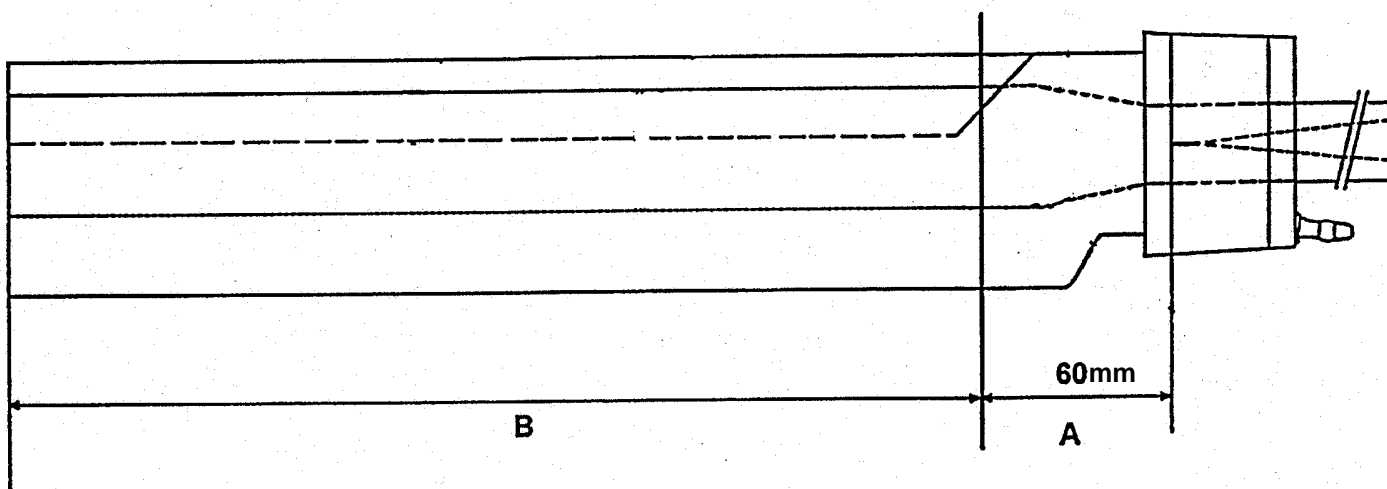
(a) Within 10 hours time-in-service (TIS) and thereafter before the first flight of each day, visually check each blade for a crack, blister, or wrinkling. An owner/operator (pilot), holding at least a private pilot certificate, may perform the visual check and must enter compliance into the aircraft maintenance records in accordance with 14 CFR sections 43.11 and 91.417(a)(2)(v)). See Figure 1 as follows:

(b) If a crack, blister, or wrinkling is found as a result of the visual check, accomplish the following before further flight (see Figure 1 of this AD):

(1) Zone A: If a blister is detected on the blade suction face, conduct a tapping test inspection on the whole blade for bonding separation.

(2) Zone B: If a crack, wrinkling, or a blister is found, replace the blade with an airworthy blade before further flight.

(2) Thereafter, at intervals not to exceed 25 hours TIS, conduct a tapping test inspection for bonding separation on blades, P/N 365A12-0020-02 or 365A12-0020-03, in Zone A as depicted in Figure 1 of this AD.

(3) Thereafter, at intervals not to exceed 100 hours TIS or 200 cycles, whichever occurs first, conduct a tapping test inspection for bonding separation on blades, P/N 365A12-0020-02 or 365A12-0020-03, in Zone B as depicted in Figure 1 of this AD. If a crack, wrinkling, or a blister is found, replace the blade with an airworthy blade before further flight.

(i) For blades, P/N 365A33-2131-all dash numbers, 365A12-0010-all dash numbers, and 365A12-0020-00, and -01, if bonding separation or a crack is found, replace the blade with an airworthy blade before further flight.

(ii) For blades, P/N 365A12-0020-02, and -03, if bonding separation exceeds 900 mm² in a 30 x 30 mm square or if there is a crack, replace the blade with an airworthy blade before further flight.

(i) If bonding separation exceeds the criteria specified in paragraph (b)(1)(ii) of this AD or if a crack is found, replace the blade with an airworthy blade before further flight.

(ii) If bonding separation is present and within tolerance of the criteria specified in paragraph (b)(1)(ii) of this AD, conduct a tapping test before the first flight of the day and as often as necessary during the day ensuring that the TIS between tapping tests does not exceed 10 hours TIS between tapping tests.

(iii) Within 25 hours TIS after the discovery of skin debonding in Zone A, remove and replace the blade with an airworthy blade.
